**AIRPROX REPORT No 2023107**

Date: 10 Jun 2023 Time: 1332Z Position: 5203N 00005E Location: 2NM SW Duxford

**PART A: SUMMARY OF INFORMATION REPORTED TO UKAB**

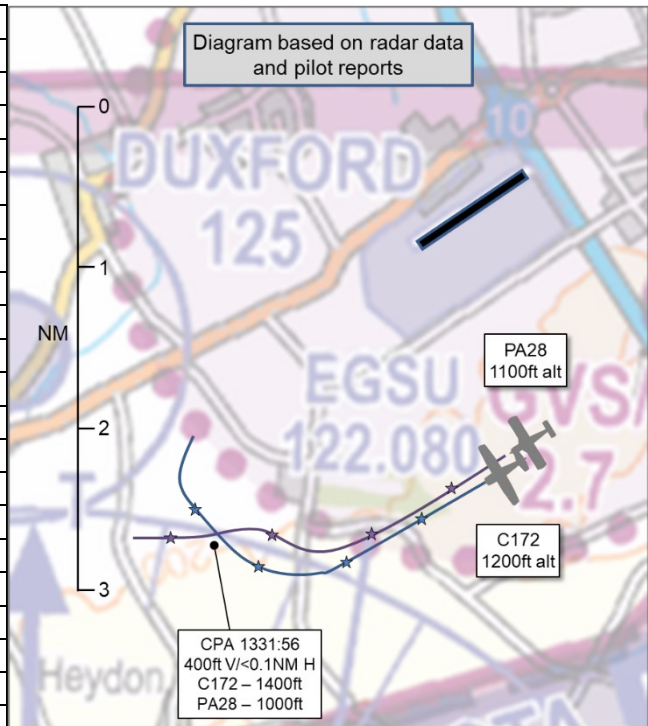
Having reviewed the radar and RT files for this event ATSI noted that, with both aircraft still downwind, the PA28 pilot who had been following the C172 by 0.2NM, reported clearing the ATZ at 1331:38 and "*picking up a track for Royston*". The C172 pilot continued downwind with the PA28 initially continuing to follow. The turn onto base by the C172 had not been obvious on the radar until 1331:49 whilst the PA28 appeared to take up a more westerly track ultimately passing 400ft underneath the C172.
