**AIRPROX REPORT No 2023141**

Date: 25 Jun 2023 Time: 1806Z Position: 5143N 00033W Location: Bovingdon Hold

**PART A: SUMMARY OF INFORMATION REPORTED TO UKAB**

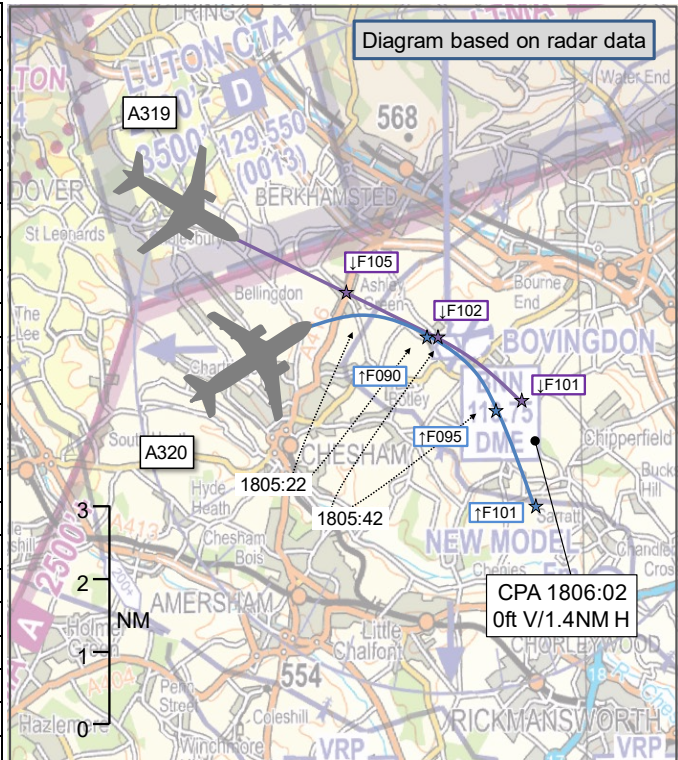
Recorded	Aircraft 1	Aircraft 2
Aircraft	A320	A319
Operator	CAT	CAT
Airspace	London TMA	London TMA
Class	A	A
Rules	IFR	IFR
Service	Radar Control	Radar Control
Provider	London Control	London Control
Altitude/FL	FL101	FL101
Transponder	A, C, S+	A, C, S+
<b>Reported</b>		
Colours	Company	Company
Lighting	'Standard'	Nav, Strobes, Beacon
Conditions	IMC	IMC
Visibility	<5km	<5km
Altitude/FL	FL090	FL100
Altimeter	1013hPa	1013hPa
Heading	165°	116°
Speed	225kt	220kt
ACAS/TAS	TCAS II	TCAS II
Alert	TA	TA
<b>Separation at CPA</b>		
Reported	Not Seen	0ft V/2NM H
Recorded	0ft V/1.4NM H <sup>1</sup>
