UK AIRPROX BOARD

Analysis of Airprox in UK Airspace

Report Number 9
July 2002 to December 2002

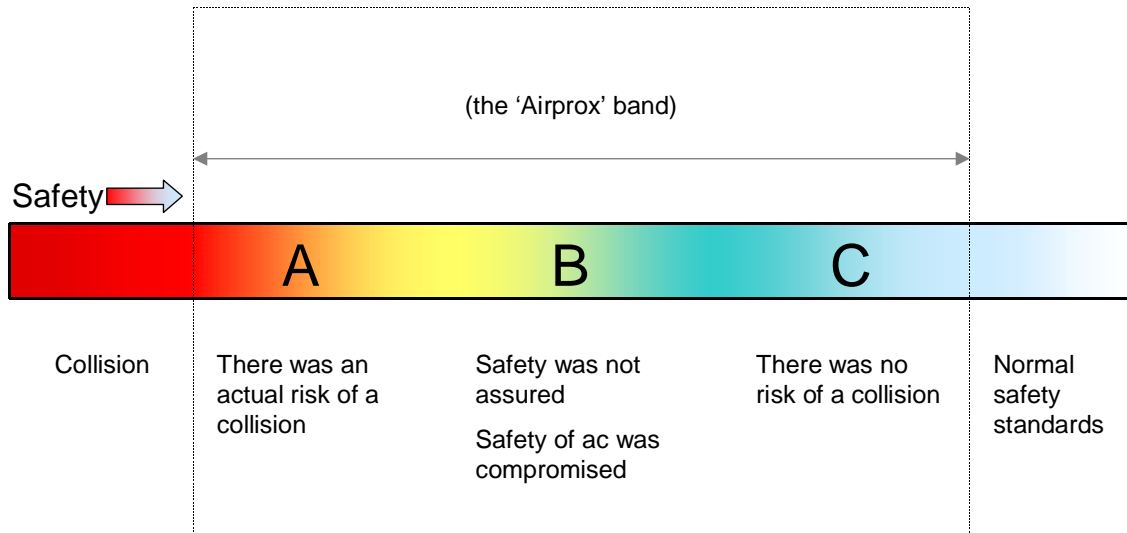
A pictorial representation of the main Airprox risk bands is shown below.

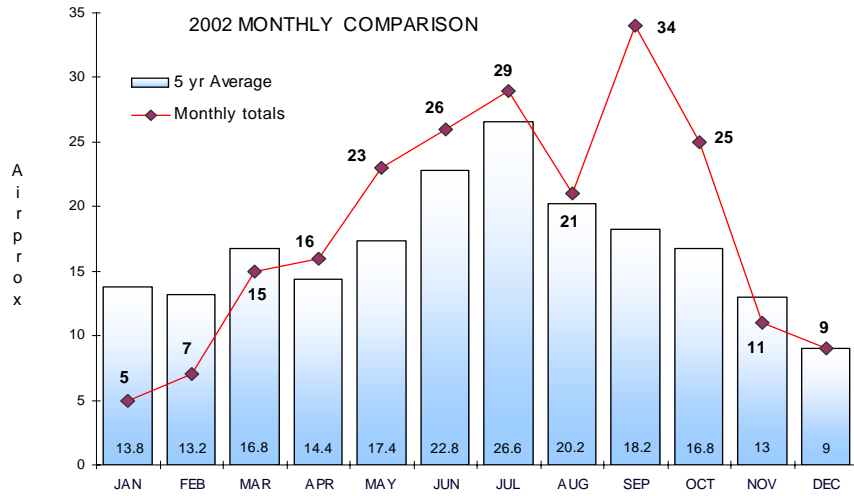
Figure 1

Fig 1 and Table 1 show the distribution of Airprox during 2002. Numbers were below normal during the first quarter, but then climbed to levels above the average from April to October inclusive.

These results reflect the general weather pattern over the UK during 2002. Unlike the previous two years, last Autumn saw long periods of fine flying conditions - and more Airprox were reported.

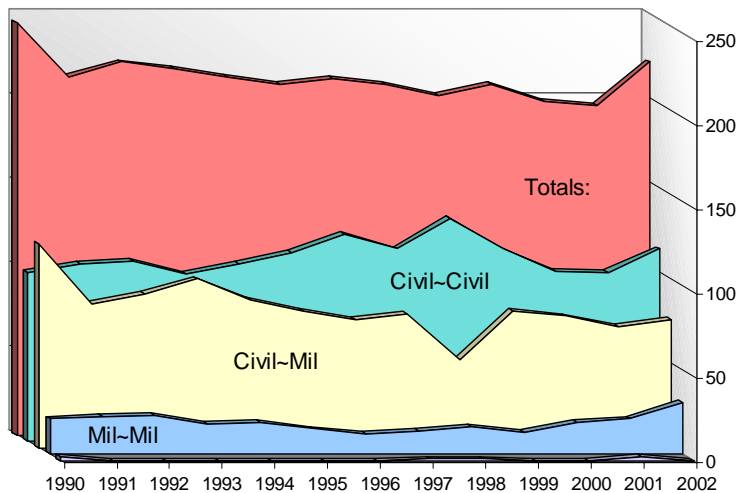
Figure 2: Airprox totals by user groups

Civil and military aircraft involvement in Airprox since 1990 is shown at Fig 2.

Most of the Airprox that make up the 'total' rate profile were conflicts between mixed Civil and Military pilots - note the dip in 1998 reflecting the same reduction that shows up in Fig 2 on page 6. Two broad points emerge from the chart above. One is that Military pilots have in recent years become more involved in reported incidents. The other is that last year saw a welcome attenuation in the risk-bearing rate, breaking what had previously been a consistent and persistent steady rise.

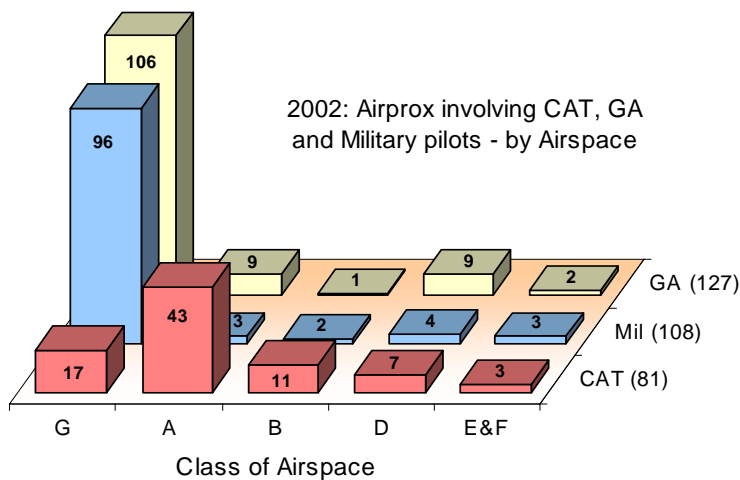
Figure 4: Airspace in which pilots experienced an Airprox

Fig 4 shows the type of airspace in which conflicts occurred, where at least one of the aircraft involved was either GA, Military or CAT. Detail on numbers is set out in the grid.

For military pilots, 88% of their Airprox numbers occurred in Class G airspace, while the corresponding figure for GA pilots was 83%. Unsurprisingly, conflicts often involved encounters between these two groups (57 cases).

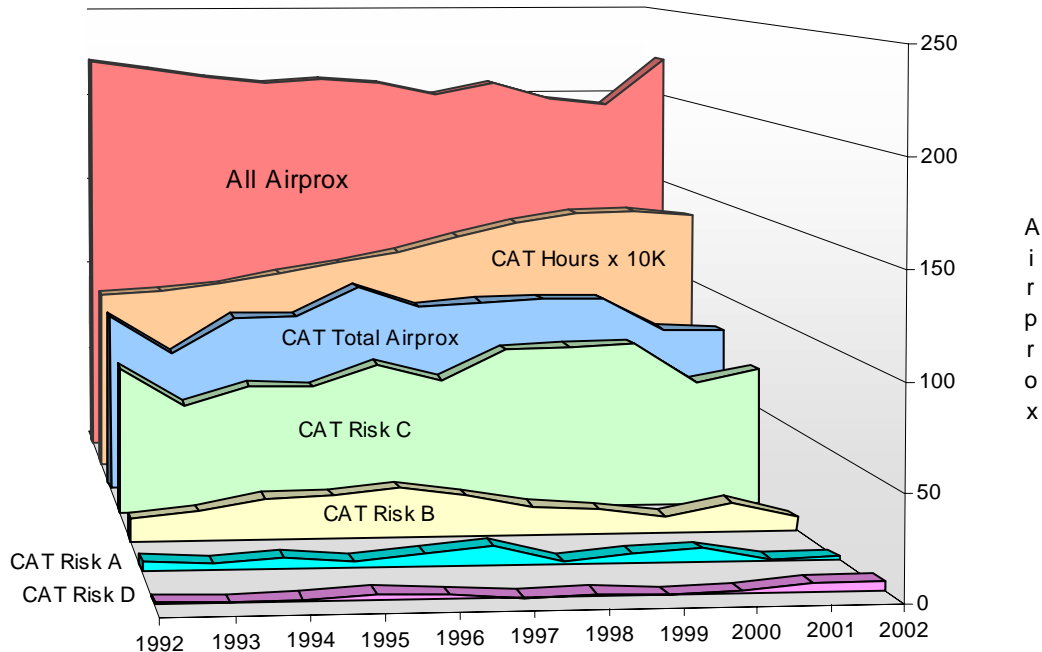
Fig 5 (below) illustrates some of the longer-term trends on risk results that come from Airprox in which CAT aircraft have been involved. The various CAT Risk profiles are set against background information representing the wider picture - 'All Airprox' - to give a sense of proportion. Additionally, CAT flying hours have been included to demonstrate the magnitude of their rising trend over the years. For those who prefer more specific detail, all of the data used to construct Fig 5 is set out for information in Table 3.

Figure 5: CAT Risk distribution 1992 - 2002

The first thing to draw attention to in Fig 5 is the relationship between the number of CAT flying hours flown and the number of Airprox that resulted. Whereas a general assumption, that more commercial flying is likely to lead to more Airprox, sounds reasonable, this has not happened, particularly over the last six years. In that period while flying hours went up Airprox numbers stabilised and then came down. Of more importance, most of the incidents turned out to have no collision risk (over 86% during 2002) and this is another trend that has endured well over the years. However, there have been, and continue to be, incidents where safety suffers compromise (Risk B); the chart shows how these compare in volume with other results. Overall Risk B results have been much fewer in number and gradually declined since their peak in the mid 90s. A similar pattern, but more so, emerges from Risk A numbers i.e. situations where an actual risk of collision had existed. There was a single example recorded in 2002 set against the CAT Airprox total of 81 incidents. Moreover, this encounter took place outside controlled airspace, away from the main airways structure. Completing the picture is a small, but nevertheless persistent, number of Airprox that cannot be assessed for risk, simply because of limited information revealed in the investigation process. There were four such cases in 2002, all against balloons whose point of origin could not be traced.

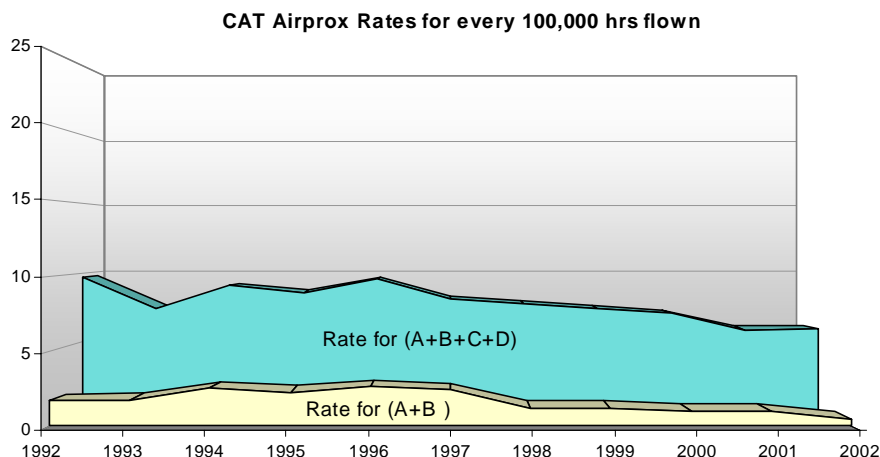
Figure 6: CAT Risk rates

Fig 6 presents risk trends in a slightly different way, based on the figures set out in Table 4. What Fig 6 depicts is the number of Airprox in every 100,000 flying hours flown by CAT aircraft in UK airspace, expressed as a rate. This gives a better insight into whether things are getting better, or worse. Two profiles are presented, one for the total picture and one for risk-bearing situations i.e. Risk A and Risk B categories. Looking first at the total rate - the green profile - this reveals a moderate but steady decline in total risk. More interesting results, however, lie in the 'yellow' risk-bearing profile. Inspection here shows that a marked stability set in from 1998 onwards and in 2002 the risk-bearing rate fell below one for the first time ever. The explanation for this very welcome downward trend in risk - is TCAS. Introduced in 1998 in growing numbers, the benefits were felt immediately and continue as more aircraft become so equipped.

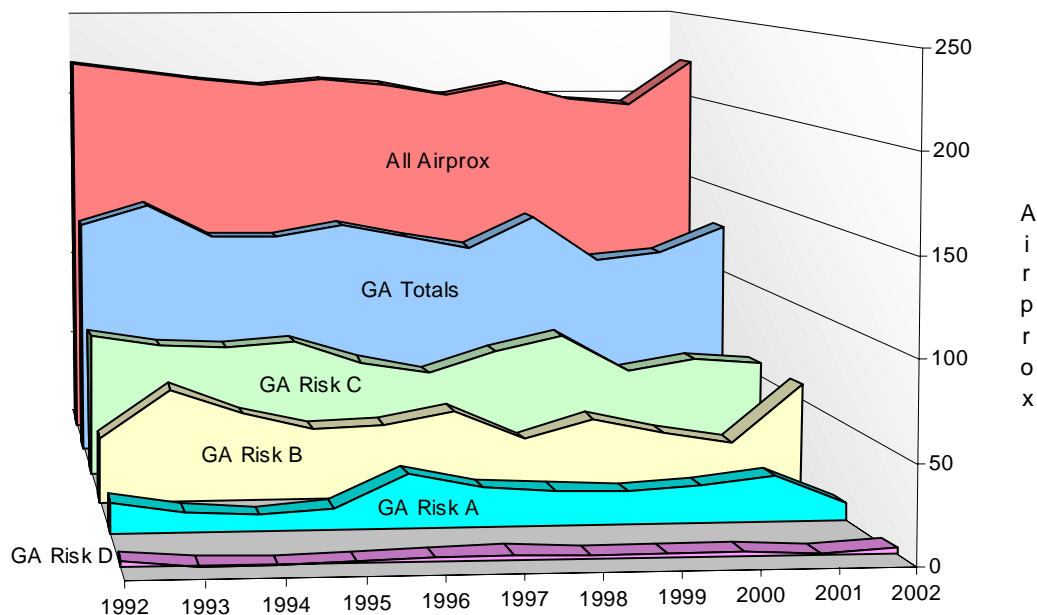
Of the three groups of pilots that fly in UK airspace, those within the GA community account for the largest and most diverse, flying everything from microlights and light fixed wing aircraft, to helicopters and a whole range of company owned modern, high performance machines. A further wide variation exists in the flying experience levels of GA pilots, which ranges from 'first solos' all the way through to those with thousands of hours. None of this, however, provides any protection or immunity from the unwelcome experience of an unplanned and unexpected close encounter in the air. Fig 8 shows how many of these have involved GA pilots over the years, which can be compared in turn against the UK grand total. For those who wish more detail, reference to Table 5 will reveal precise figures.

Figure 8: GA Risk distribution 1992 - 2002

Broadly speaking, GA pilots have taken part in just under 60% of all Airprox in UK airspace each consecutive year. In more recent years a little over half of these incidents resulted in no collision risk, leaving a fairly high proportion that ended up in the 'safety not assured' or 'actual collision risk' categories. Profiles for these two latter situations show variations - Risk B more so than Risk A - but the Risk B numbers had started to come down, while those for Risk A were reasonably consistent ... until 2002. Last year saw a welcome dive in collision risk 'A' returns, but these appear to have been achieved at the expense of much higher 'B' cases; these outcomes shot up sharply to 58 and just ahead of the 'no collision' Risk C total. Weather conditions can be an accurate barometer to reflect GA Airprox numbers, but other factors often determine just how close pilots manage to get to each other's aircraft, unseen. One major factor is aircraft colour. Many light aircraft and most gliders are white and this can serve to provide little or no contrast against background features. It is the lack of contrast, frequently accompanied by lack of movement in the windscreen, that makes many aircraft difficult to see even in very good conditions of visibility and it explains in part why the ratio between Risk C:Risk B was so unfavourable during 2002's good weather.

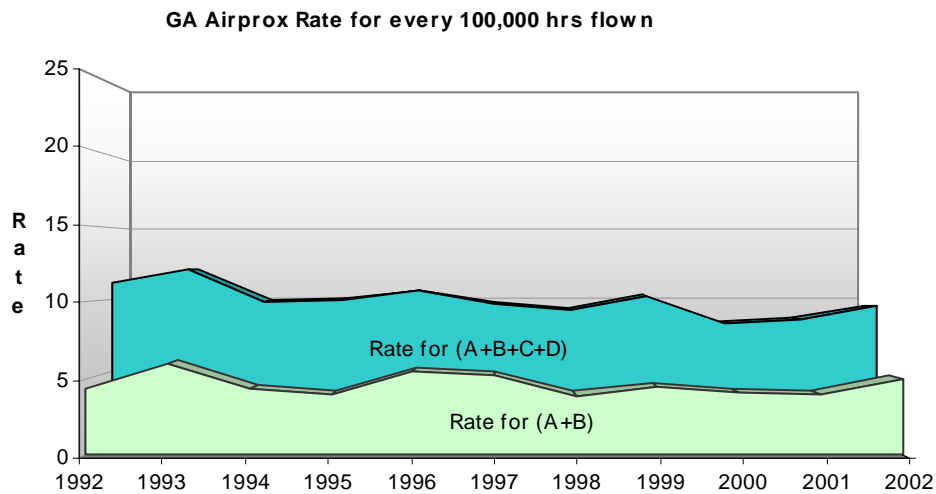
Fig 9 shows rate results for Airprox involving GA pilots. Figures are calculated on the number of incidents per 100,000 GA flying hours each year and derive from the information set out in Table 6, based on data supplied by the CAA.

Figure 9: GA Rates

While there has been no marked variance in movement for either of the two profiles shown, the total GA rate in 2002 edged upwards, as did the risk-bearing rate which moved to its highest level for five years. The reason behind the latter trend can be attributed almost wholly to the leading two elements in Fig 10.

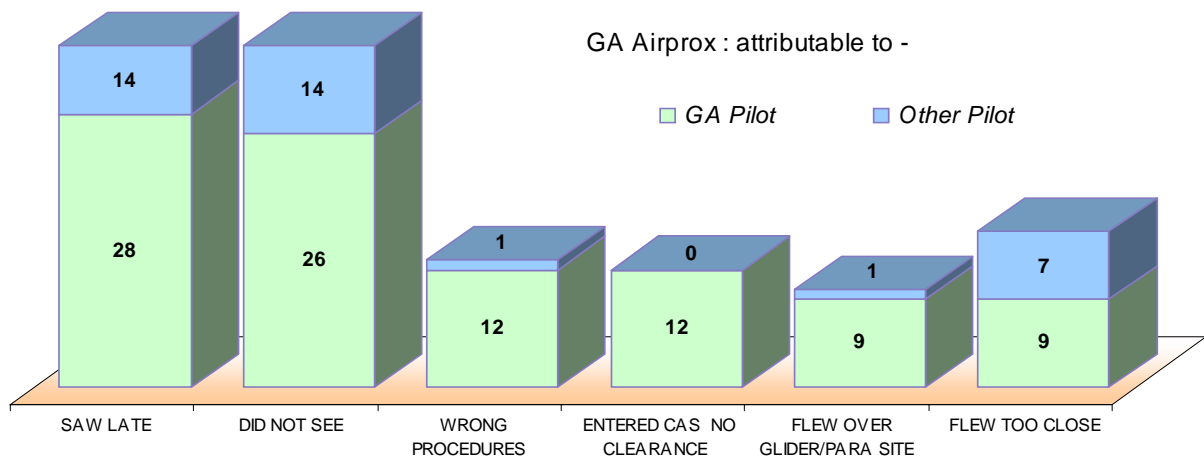
Factors behind most 'GA Airprox' remain largely unchanged and difficulties in seeing the other aircraft continue to dominate the scene for reasons that are well understood and documented. Fig 10 illustrates findings for 2002; some form of affordable Collision Warning System is needed to achieve improvements.

Figure 10: The most common reasons for Airprox involving GA pilots during 2002

Fig 13 shows the most common reasons for conflicts in which Military pilots took part. None is new but all correlate with the factors experienced by GA pilots (see Fig 10). Both groups need, and would benefit greatly from, some form of affordable Collision Warning System.

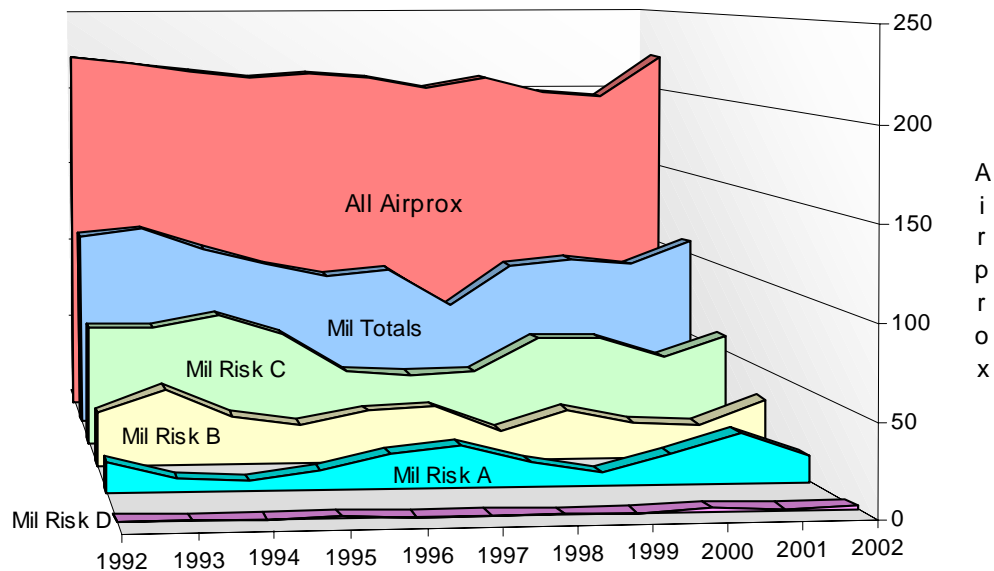
During 2002, Military pilots were involved in 108 Airprox, or 49% of the year's total Airprox figures. Whereas this percentage result has remained virtually unchanged for the last three years, the number of incidents filed in 2002 was the highest for nine years. Fig 11 shows how the various totals compare in movement, together with the risk profiles that emerge from them. More detailed figures are set out in Table 7.

Figure 11: Military risk distribution

Last year 55% of all the encounters that Military pilots were party to had outcomes in which no collision risk was involved. This situation for Risk C, where 'more' means 'better', represents a 5% improvement on results for 2001. There were two additional cases that were assessed as Risk D - situations in which insufficient information was revealed during the investigation to permit any sensible assessment on hazard.

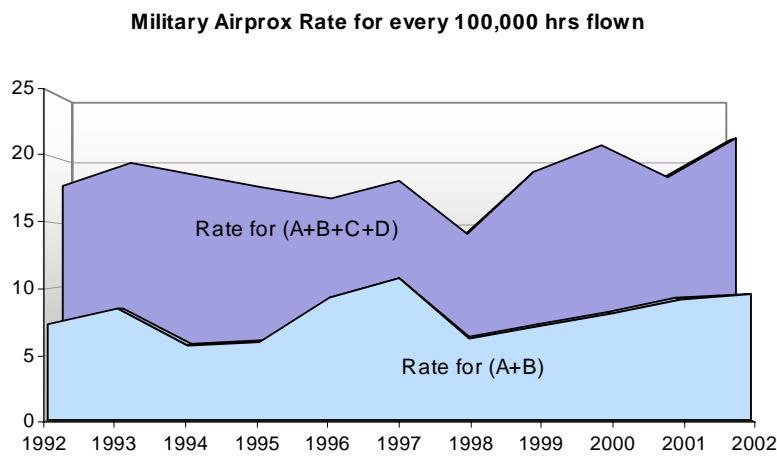
Fig 12 shows rate results since 1992 for Airprox involving Military pilots; rates are calculated using the number of incidents per 100,000 Military flying hours each year and derive from the information set out in Table 8 below.

Figure 12: Military risk rates

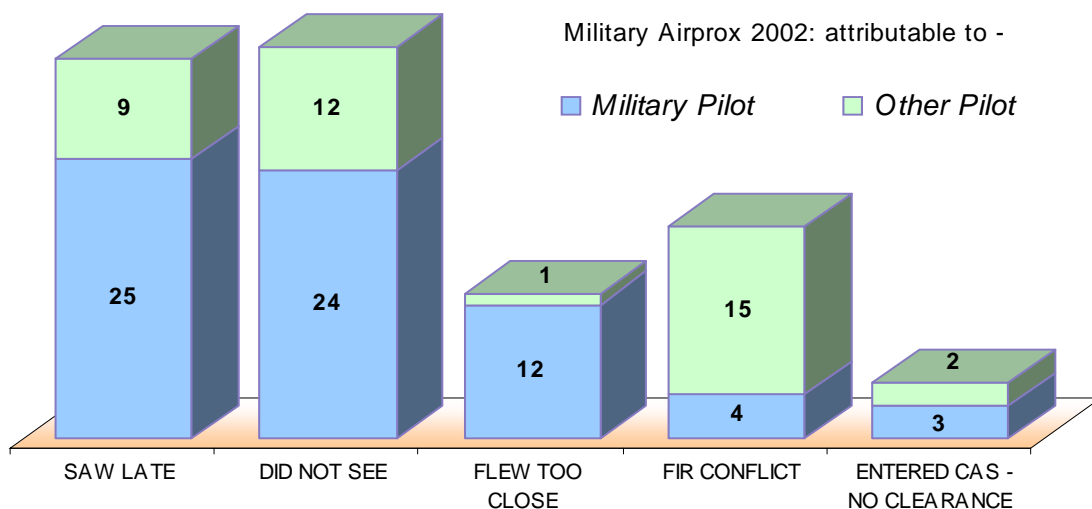
Figure 13: The most common reasons for Airprox involving Military pilots during 2002

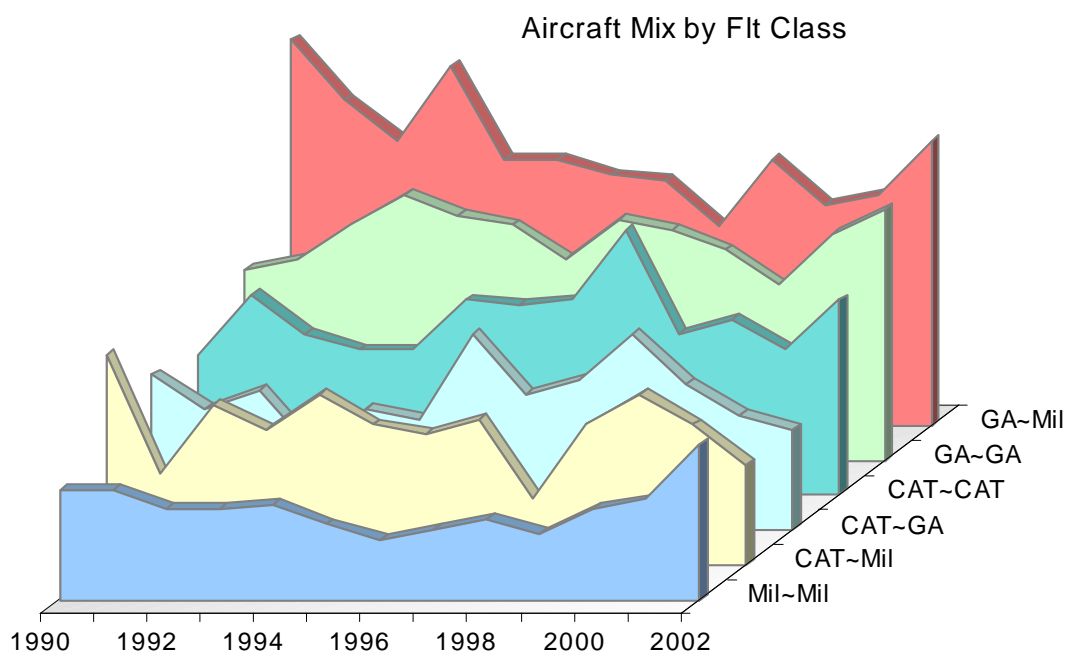
Figure 14: Airprox trends by Flight Classification

There are six different Airprox combinations in which CAT, GA and Military pilots can meet and the chart at Fig 14 illustrates how trends in these, in terms of numbers, have run since 1990. Each of the profiles is based on the data set out below in Table 9.

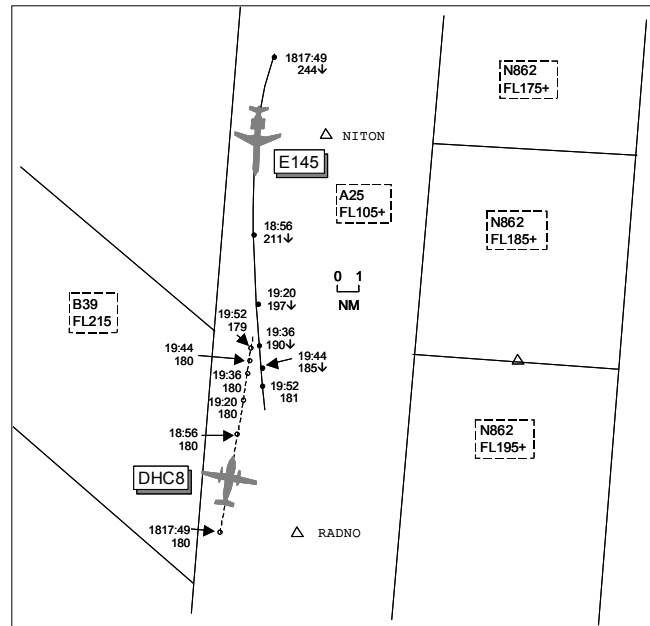
Reported Separation:
NK 100ft V 0.6nm H

Recorded Separation:
500ft V 0.6nm H

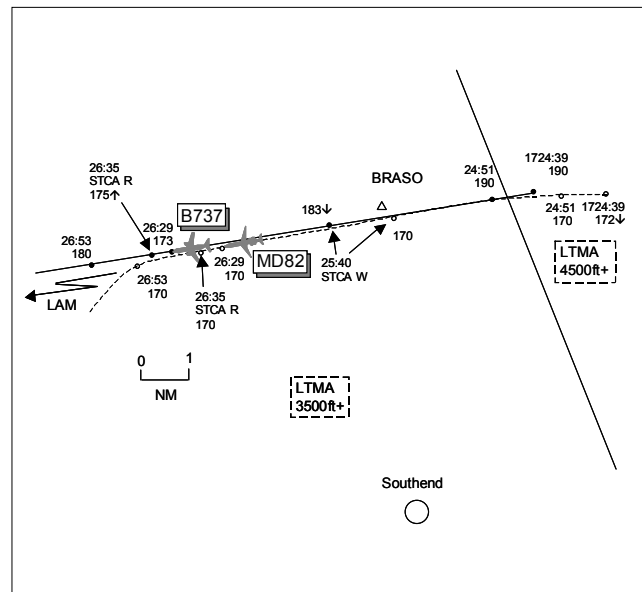
Recorded Separation:

300ft V 1.2nm H

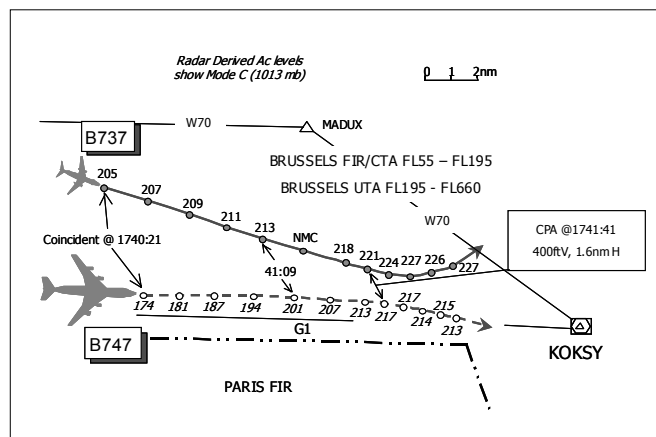
Reported Separation:

400ft V, 1.6nm H

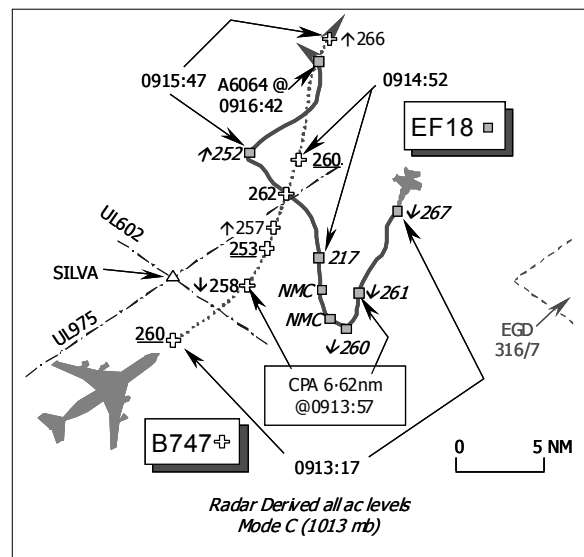
AIRPROX REPORT NO 114/02

Date/Time: 15 Jul 0914
Position: 5358N 0052E (6½nm E of SILVA)
Airspace: UAR/MRSA (Class: B)
Reporting Aircraft Reported Aircraft
Type: B747-200 EF18
Operator: CAT Foreign Mil
Alt/FL: FL260 FL250↓
Weather NIL CLOUD VMC CLOC
Visibility: 'Good' 10km+
Reported Separation:
 Not seen 3nm H, 500ftV
Recorded Separation:
 6.62nm H, 300ft V

What was clear from the radar recording was that the EF18 was both above FL245 and outside the lateral confines of EGD316/7 at the CPA. Hence, the EF18 pilot had penetrated the Class B airspace of the London Mandatory Radar Service Area without clearance, where flight under a RCS was mandatory. The Board concluded that this was the cause of this Airprox, insofar as the EF18 pilot did not comply with ACMI procedures and penetrated Class B CAS without clearance and had flown into conflict with the B747. The subsequent TCAS RA descent followed by the B747 pilot, together with the avoiding action turn initiated by S10, resolved the conflict without any erosion of standard separation. Furthermore, the EF18 pilot had kept the airliner in sight and avoided it visually, although this was not a see and avoid environment and VFR flight was not permitted adjacent to the UAR in Class B airspace. But it was evident that several safety nets had all played their part in preventing these two ac flying into unsafe proximity, therefore, the Board concluded that no risk of a collision had existed in the circumstances reported here.

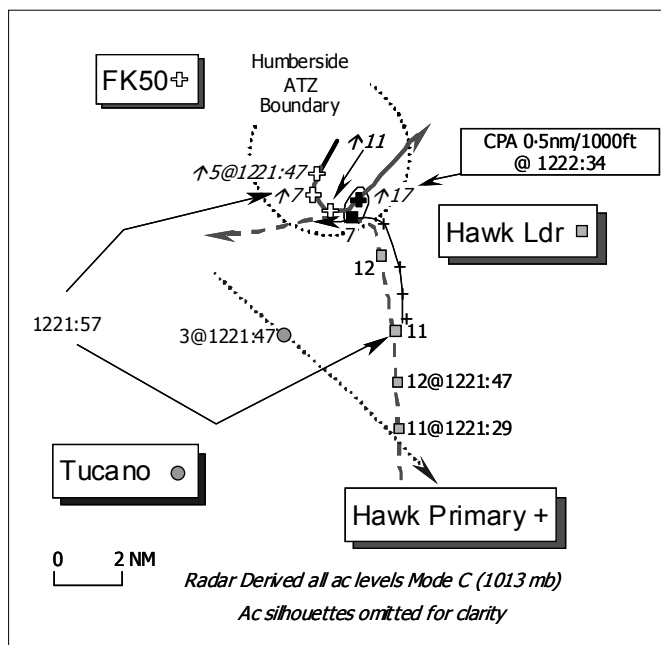
AIRPROX REPORT NO 123/02

Date/Time: 19 Jul 1222
Position: 5332 N 0020 W (2nm SSE of Humberside)
Airspace: Humberside ATZ (Class: G)
Reporting Aircraft Reported Aircraft
Type: FK 50 Hawk
Operator: CAT HQ PTC
Alt/FL: 800ft 1000ft
 (QNH 1018mb) (RPS 1015mb)
Weather VMC CLBC VMC CLOC
Visibility: 10km >10km
Reported Separation:
 5-600ft V, 800 - 1000ft
 <1/4nmH
Recorded Separation:
 1/2nm H, 1000ftV [Hawk Ldr A7003]

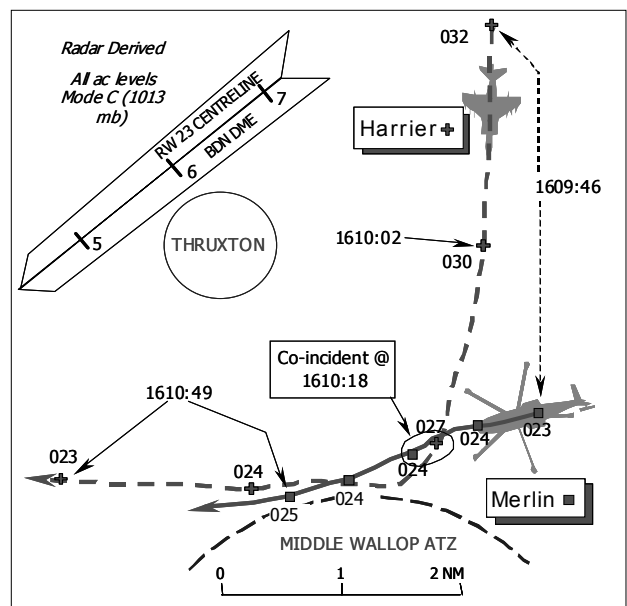
AIRPROX REPORT NO 132/02

Date/Time: 29 Jul 1615
Position: 5110 N 0135 W (8nm E of Boscombe Down - elev 407 ft)
Airspace: (Class: G)
Reporting Aircraft Reported Aircraft
Type: Merlin Harrier GR7
Operator: DPA DPA
Alt/FL: 2200 ft ↓1500ft
 (QFE 1003 mb) (QFE 1003mb)
Weather VMC HAZE VMC CLBC
Visibility: 2.0nm >10km
Reported Separation:
 200yd H, 200ft V ½-1nm H, 500ftV
Recorded Separation:
 300yd H, 2-300ft V

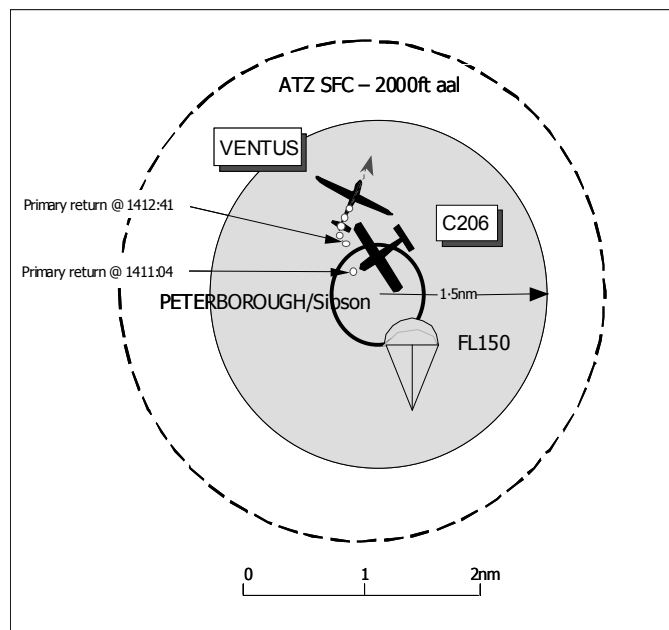
AIRPROX REPORT NO 133/02

Date/Time: 27 Jul 1411 (Saturday)
Position: 5233N 00023W (Overhead Peterborough/Sibson - elev 100ft ft)
Airspace: London FIR (Class: G)
Reporting Aircraft Reported Aircraft
Type: C206 Ventus 2CT
Glider
Operator: Civ Club Civ Pte
Alt/FL: 3500ft 2500ft
(QNH) (Marham QFE 1014mb)
Weather VMC CAVOK VMC CLBC
Visibility: >20km 15km
Reported Separation:
400ft V, nil H Not Seen
Recorded Separation:
NR

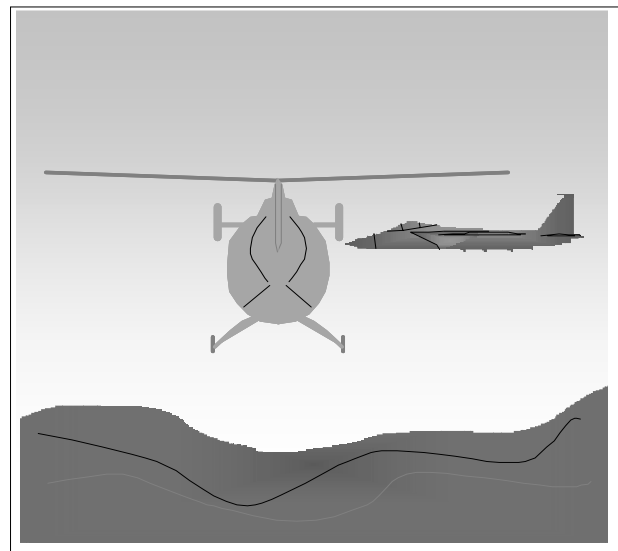
AIRPROX REPORT NO 142/02

Date/Time: 20 Aug 1633z
Position: 5154 N 0356 W (15nm N of Swansea)
Airspace: LONDON FIR (Class: G)
Reporting Aircraft Reported Aircraft
Type: Bo 105 F-15
Operator: Civ Comm Foreign Mil
Alt/FL: 1000 ft 1000 ft
(QNH 1018 mb) (msd)
Weather VMC CLOC VMC CLOC
Visibility: 50 km NR
Reported Separation:
300m H, 0ft V 600m H, 500ft V
Recorded Separation:
Not Recorded

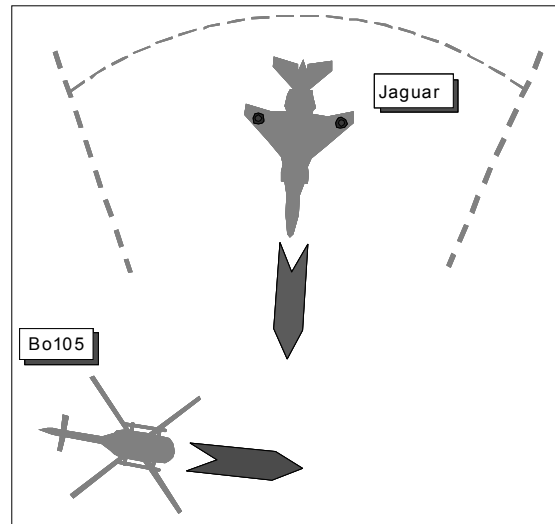
AIRPROX REPORT NO 143/02

Date/Time: 19 Aug 1444
Position: 5149 N 0435 W (Whitland)
Airspace: FIR / UKLFS (Class: G)
Reporting Aircraft **Reported Aircraft**
Type: Bo105 Jaguar
Operator: Civ Comm HQ STC
Alt/FL: 800ft 600ft
(RPS 1010 mb) (Rad Alt)
Weather VMC CLBC VMC CLBC
Visibility: 50 km 15 km
Reported Separation:
0 H, 50ft V ¼nm H, 0 V
Recorded Separation:
Not Recorded

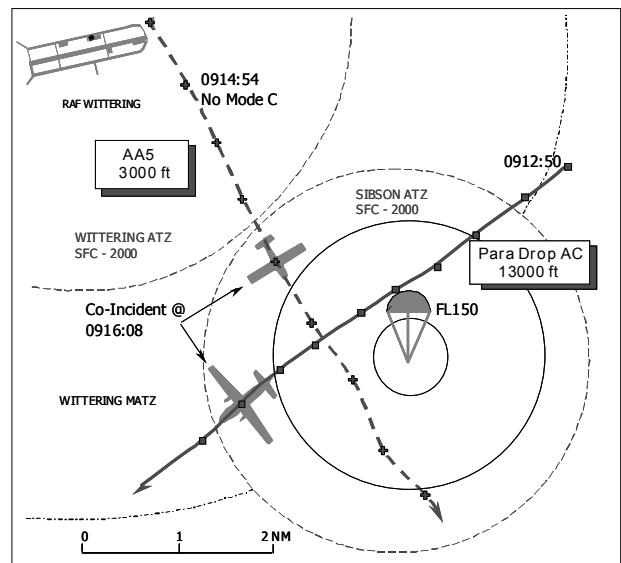
AIRPROX REPORT NO 158/02

Date/Time: 7 Sep 0915 (Saturday)
Position: 5233 N 0023 W (Sibson Free Fall Drop Zone - elev 100ft)
Airspace: London FIR (Class: G)
Reporting Aircraft **Reported Aircraft**
Type: Parachutists Grumman AA5
Operator: Civ Pte Civ Pte
Alt/FL: 3000ft 000ft
 (NK) (QNH)
Weather VMC VMC CAVOK
Visibility: NK 10km
Reported Separation:
 100ft H 100ft V NK
Recorded Separation:
 Not Recorded

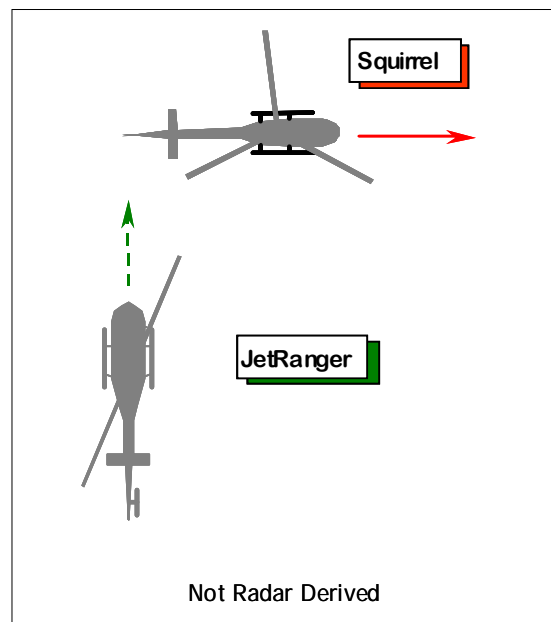
Date/Time: 16 Sep 1425
Position: 5110N 0120W (1nm E of Bullington Cross)
Airspace: UKLFS/FIR (Class: G)
Reporting Aircraft Reported Aircraft
Type: Bell 206 Single Squirrel
Operator: Civ Comm HQ DAAvn
Alt/FL: 400 ft NR
 (agl)
Weather VMC CLNC VMC
Visibility: 10km+ NR
Reported Separation:
 200m H, 50-100ftVNot seen
Recorded Separation:
 Not Recorded

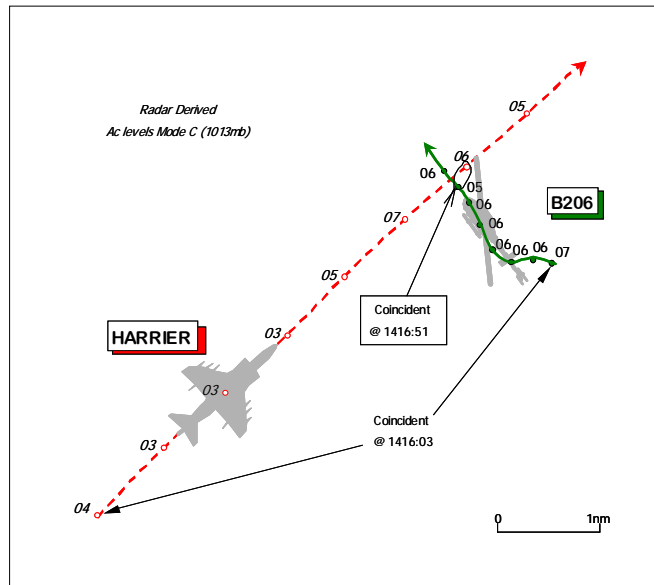
0.25nm H, 100ft V

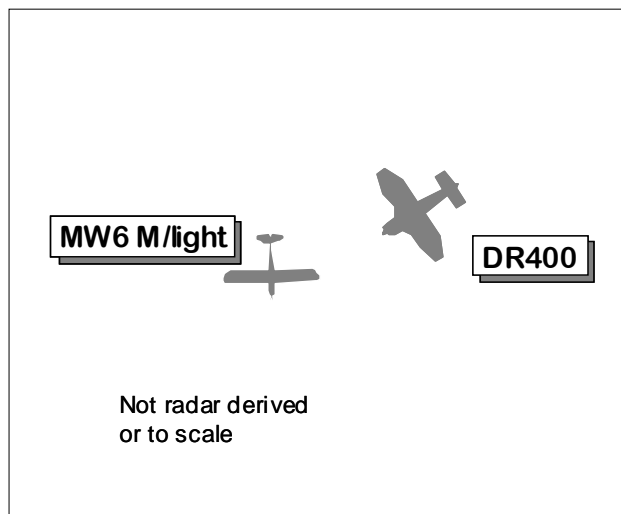
AIRPROX REPORT NO 201/02

Date/Time: 5 Oct 1407 (Saturday)
Position: 5134N 0223W (2nm NE of Yate)
Airspace: FIR (Class: G)
Reporting Aircraft Reported Aircraft
Type: MW6 M/Light DR400
Operator: Civ Pte Civ Pte
Alt/FL: 1950ft ↓ 2500ft
(QNH 1026mb) (QNH)
Weather VMC CLBC VMC CLNC
Visibility: 40nm >10km
Reported Separation:
30ft V 150ft H 200-300ft H
Recorded Separation:
not recorded

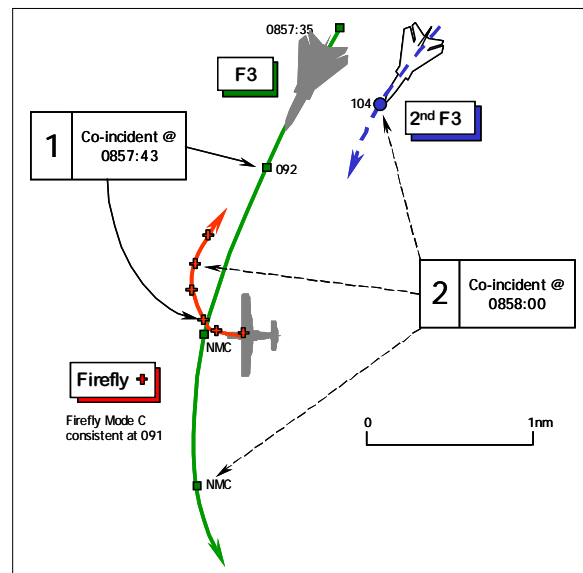
AIRPROX REPORT NO 207/02

Date/Time: 23 Oct 0857
Position: 5254N 0020W (10nm E of Barkston Heath)
Airspace: Lincolnshire AIAA (Class: G)
Reporting Aircraft Reported Aircraft
Type: No3 Tornado F3 Firefly 260
Operator: HQ STC HQ PTC
Alt/FL: 8400ft FL90
 RPS (985mb)
Weather VMC CLOC VMC CLAC
Visibility: 30km >20Km
Reported Separation:
 600ft H, 600ft V No3 F3 not seen
Recorded Separation:
 c260m H

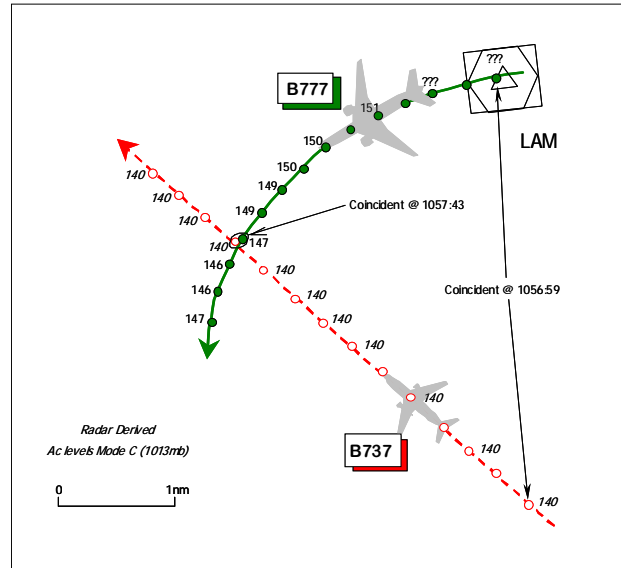
AIRPROX REPORT NO 208/02

Date/Time: 22 Oct 1057
Position: 5137N 00005E (2.75nm SW Lambourne (LAM) VOR)
Airspace: London TMA (Class: A)
Reporting Aircraft Reported Aircraft
Type: B777 B737
Operator: CAT CAT
Alt/FL: ↓FL140 FL140
Weather NK NK
Visibility: NK NK
Reported Separation:
1nm H, 500ft V 600ft V
Recorded Separation:
Nil H, 600ft V

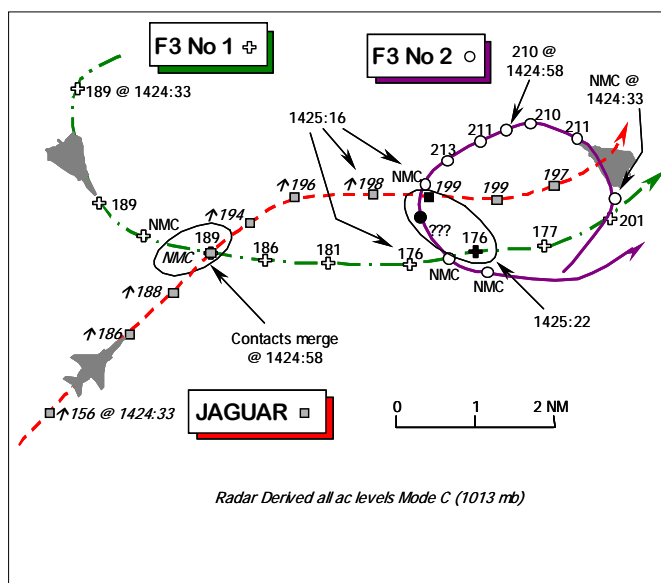
F3No1/Jag: contacts merged

F3No2/Jag: < 0.32nm H

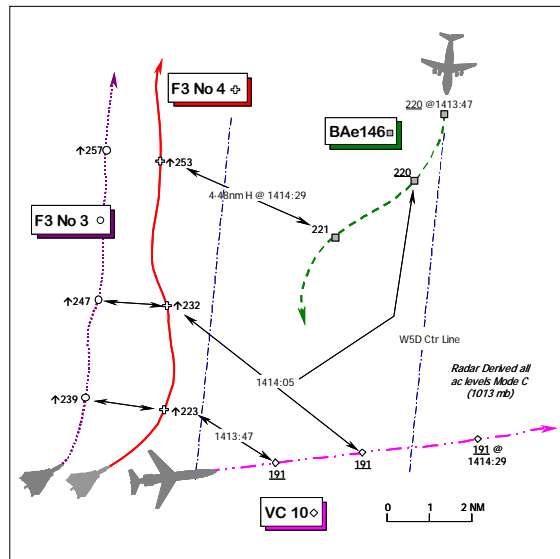
AIRPROX REPORT NO 212/02

Date/Time: 29 Oct 1414
Position: 5819N 0145W (35nm S of BEKET)
Airspace: ADR-W5D/FIR/ (Class: F/G/B) UIR
Reporting Aircraft Reported Aircraft
Type: BAe146-200 Tornado F3
Operator: CAT HQ STC
Alt/FL: FL220 NR
 (QNH)
Weather VMC No Cloud VMC NR
Visibility: Good NR
Reported Separation:
 500ft V, 1nm H 11nm H
Recorded Separation:
 4.48nm H - 10.81nm H -
 3200ftV 100ft V

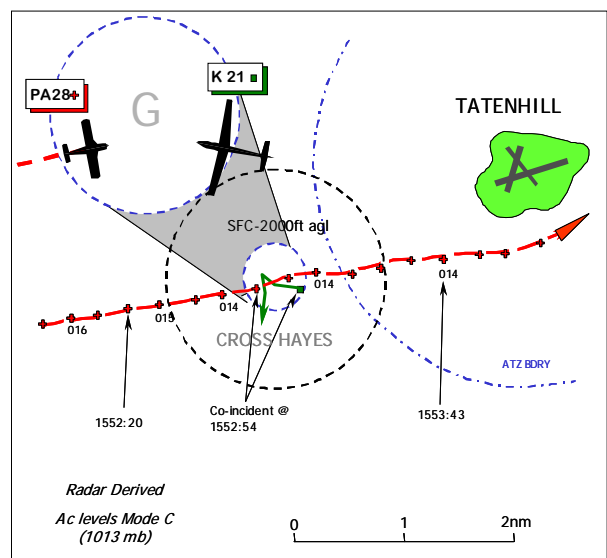
AIRPROX REPORT NO 213/02

Date/Time: 19 Oct 1553 (Saturday)
Position: 5247 N 0149 W (6nm W of Burton-on-Trent)
Airspace: London FIR (Class: G)
Reporting Aircraft Reported Aircraft
Type: K21 Glider PA28
Operator: Civ Club Civ Pte
Alt/FL: 1200ft 1000ft
 (agl) (agl)
Weather VMC VMC CLOC
Visibility: 8km 25km
Reported Separation:
 100ft H, 100ft V 500m H, 200ft V
Recorded Separation:
 Contacts merged

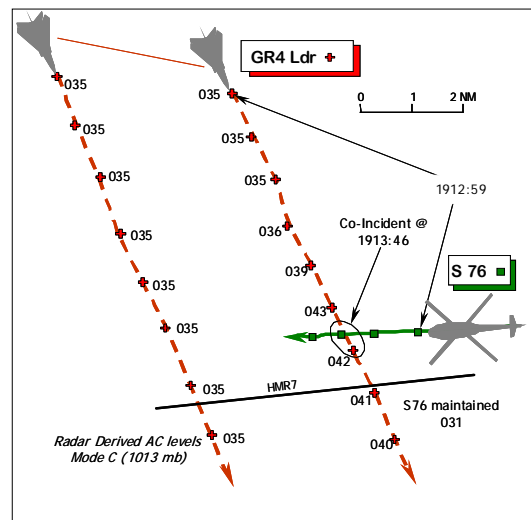
AIRPROX REPORT NO 221/02

Date/Time: 12 Nov 1913 NIGHT
Position: 5341N 0039E (25nm E of Otringham)
Airspace: London FIR (Class: G)
Reporting Aircraft Reported Aircraft
Type: S-76 Tornado GR4pr
Operator: Civ Comm HQ STC
Alt/FL: 2500ft 3800ft
 RPS (989mb) (Rad Alt)
Weather VMC VMC SKC
Visibility: 30km 50km
Reported Separation:
 nil H, 400ft V <1nm H, 1000ftV
Recorded Separation:
 11-1200ft V - tracks crossed,

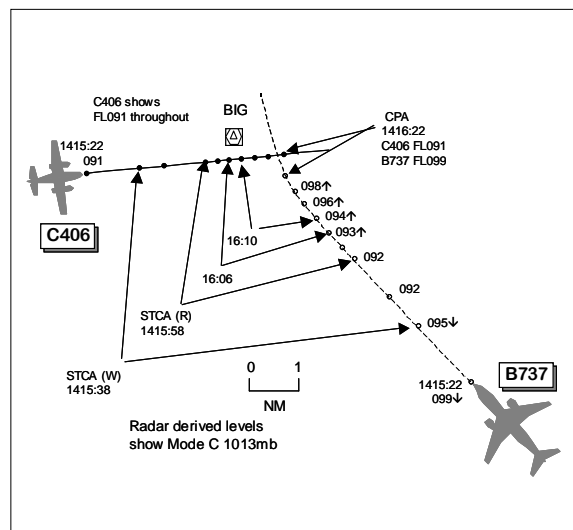
Date/Time: 5 Dec 1416
Position: 5119N 0003E (1nm SE BIG)
Airspace: TMA (Class: A)
Reporting Aircraft Reported Aircraft
Type: B737-500 C406
Operator: CAT Civ Comm
Alt/FL: ↓FL70 FL90

Weather VMC CLOC VMC CLAC
Visibility: 10km >10km
Reported Separation:
 400ft V nil H not seen
Recorded Separation:
 800ft V 0.5nm H

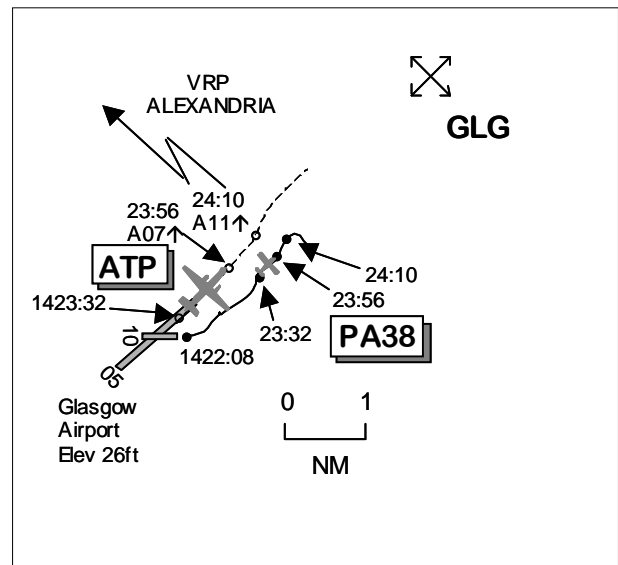
Recorded Separation:

0.33nm H

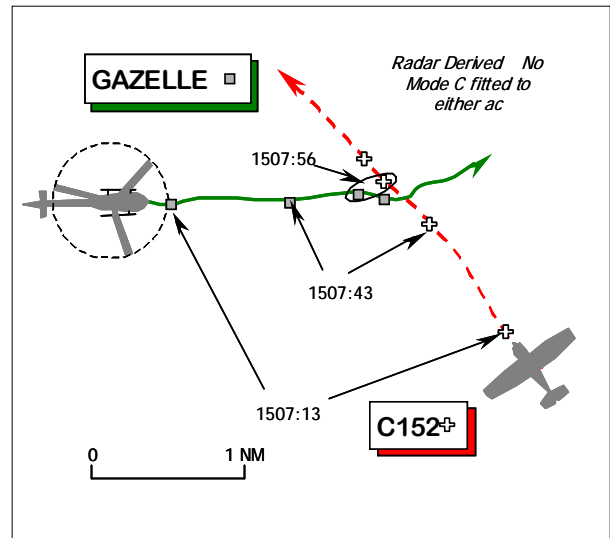
AIRPROX REPORT NO 239/02

Date/Time: 19 Dec 1507
Position: 5151N 0056E (2nm S of Colchester)
Airspace: UKLFS/London (Class: G) FIR
Reporting Aircraft Reported Aircraft
Type: Gazelle Cessna 152
Operator: HQ JHC Civ Club
Alt/FL: 500ft 1000ft
 (Rad Alt) (QNH 1027mb)
Weather VMC CLBC VMC HAZE
Visibility: 25km+ 10km
Reported Separation:
 50-100m, nil V 500ft H, 30ft V
Recorded Separation:
 0-17nm

The lack of Mode C fitted to either ac precluded any independent assessment of the vertical separation that pertained here, but the Board noted that the Gazelle pilot had reported flying at a height of 500ft Rad Alt, and the C152 QFI stated that only 30ft of vertical separation had existed above the helicopter. Notwithstanding any error in assessment in the short time available, this did not jibe with the C152 pilot's reported altitude of 1000ft QNH overhead Colchester. Although the student might have inadvertently descended the C152 lower than his instructor had realised, this was conjecture and the Board was unable to resolve this apparent anomaly. Despite these late sightings, both pilots were able to effect avoiding action in the time available, though that of the C152 crew probably had little effect on the outcome. Nonetheless, the radar recording showed that only 315m horizontal separation was

achieved by the combined actions of both crews. Whilst this was sufficient to prevent a collision, in the Board's view the safety of the subject ac had been compromised. Furthermore, a GA member remarked that if the occurrence was in the close vicinity of the built up area of Colchester, the C152 crew might have encountered difficulty in "alighting clear" in the event of a power failure at this altitude, as is required by Rule 5 of the Rules of the Air Regulations 1996.
