## **AIRPROX REPORT No 2021136**

Date: 03 Aug 2021 Time: 1021Z Position: 5205N 00128W Location: Edgehill airfield

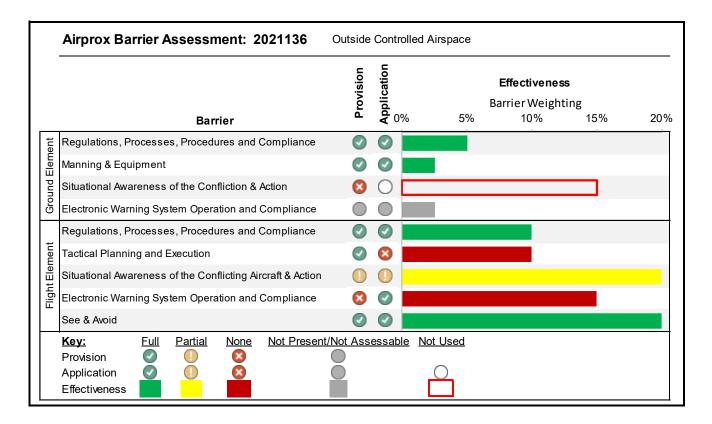
# Safety Barrier Assessment<sup>4</sup>

<sup>&</sup>lt;sup>4</sup> The UK Airprox Board scheme for assessing the Availability, Functionality and Effectiveness of safety barriers can be found on the UKAB Website.
